# Mobile Intel® Pentium® 4 Processor with 533 MHz System Bus

Specification Update

Document Number: 253176-021

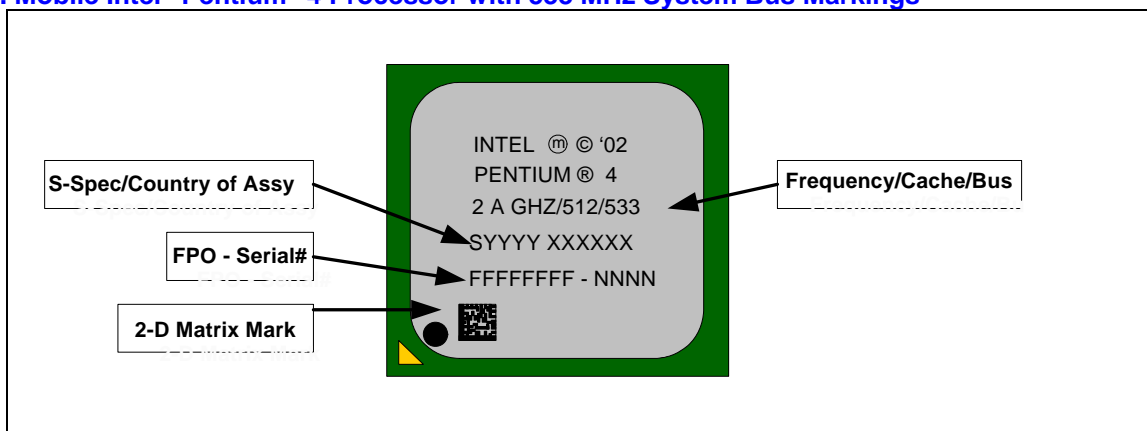
Figure 1. Mobile Intel® Pentium® 4 Processor with 533 MHz System Bus Markings

## Component Marking Information
